Infrared Thermography in the Dumont Residence March 2006

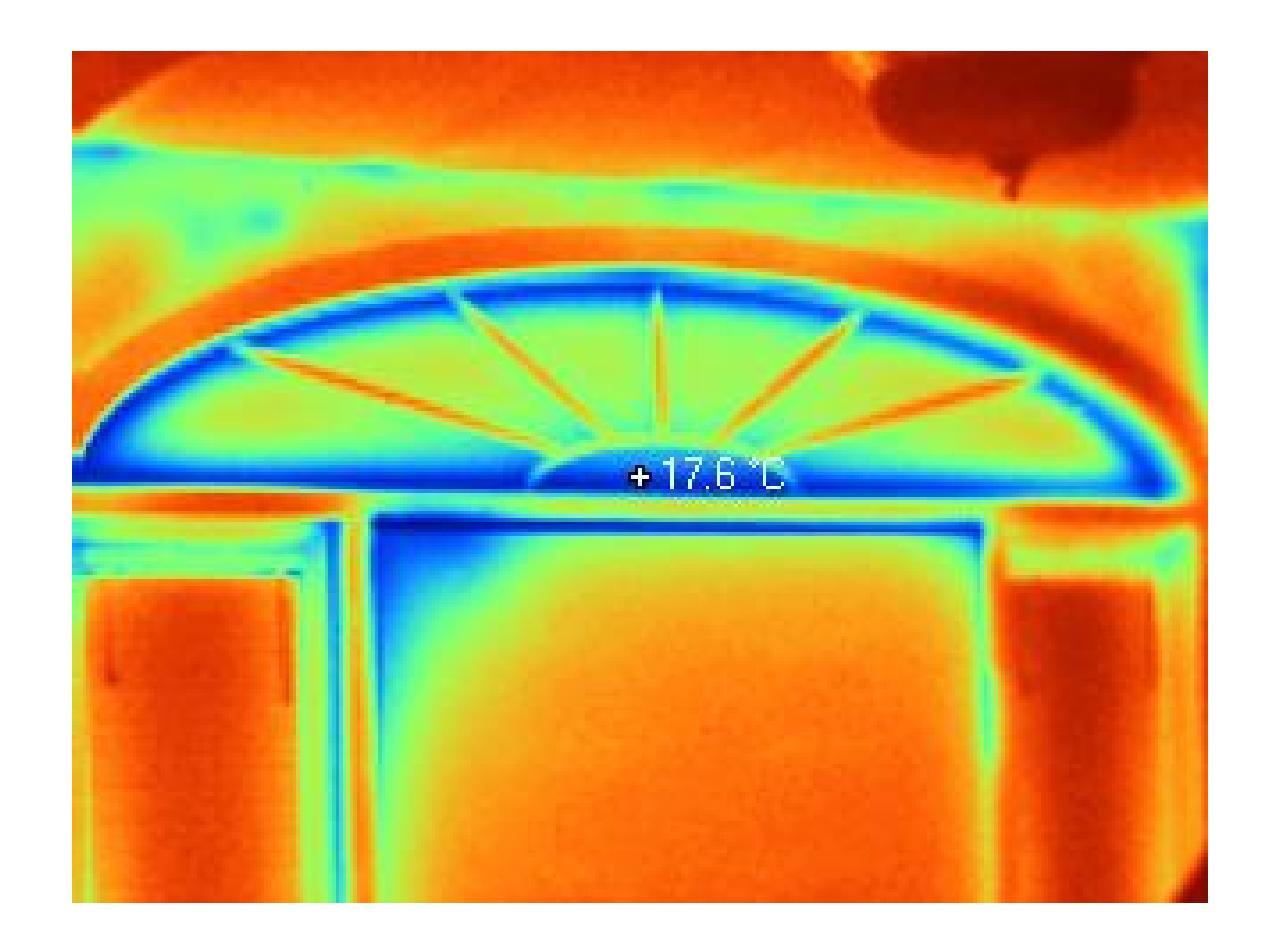
# Fanlight over Front Door

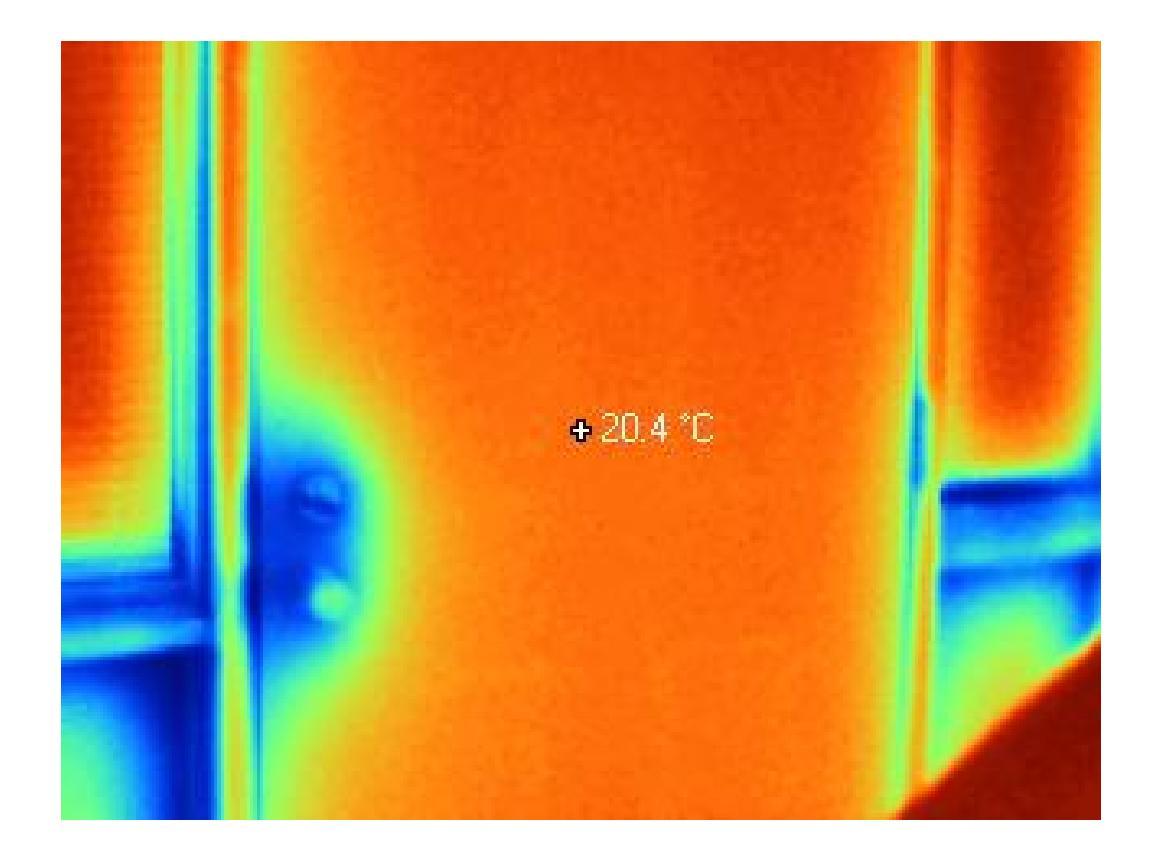
### Front Door Locks

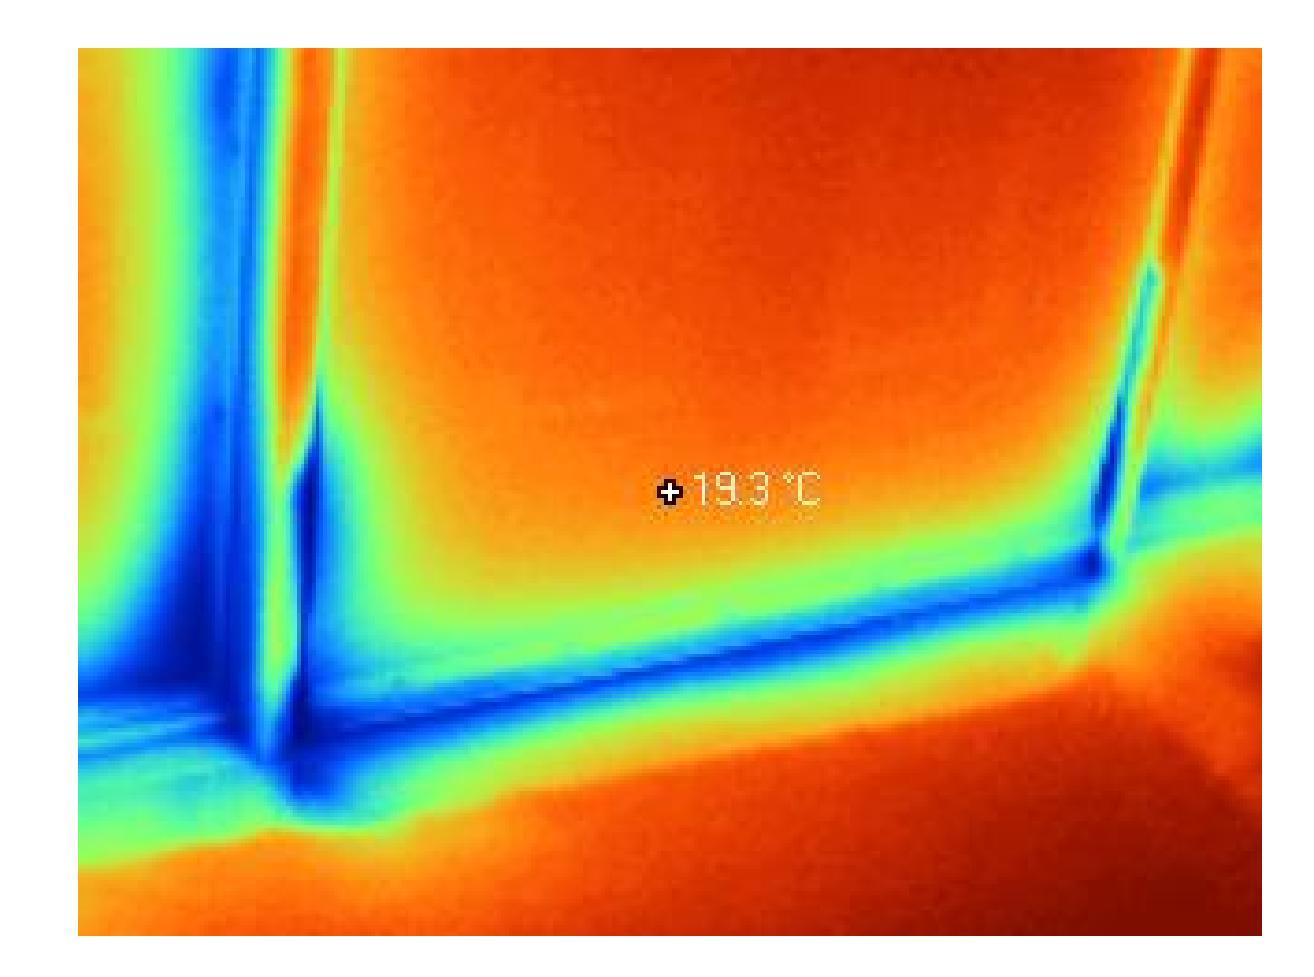
### **Bottom of Front Door**

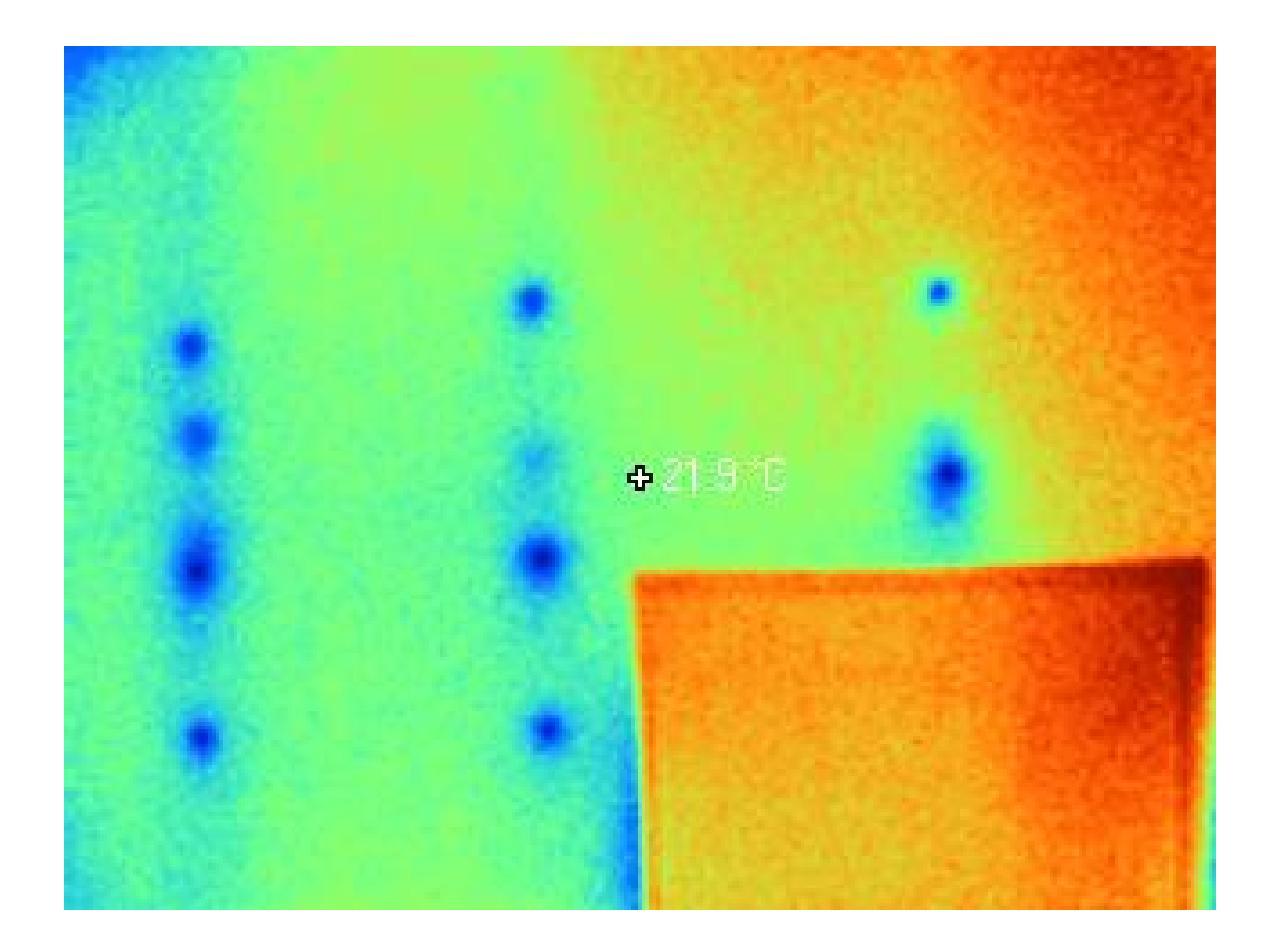
#### Drywall Screws in the North Wall

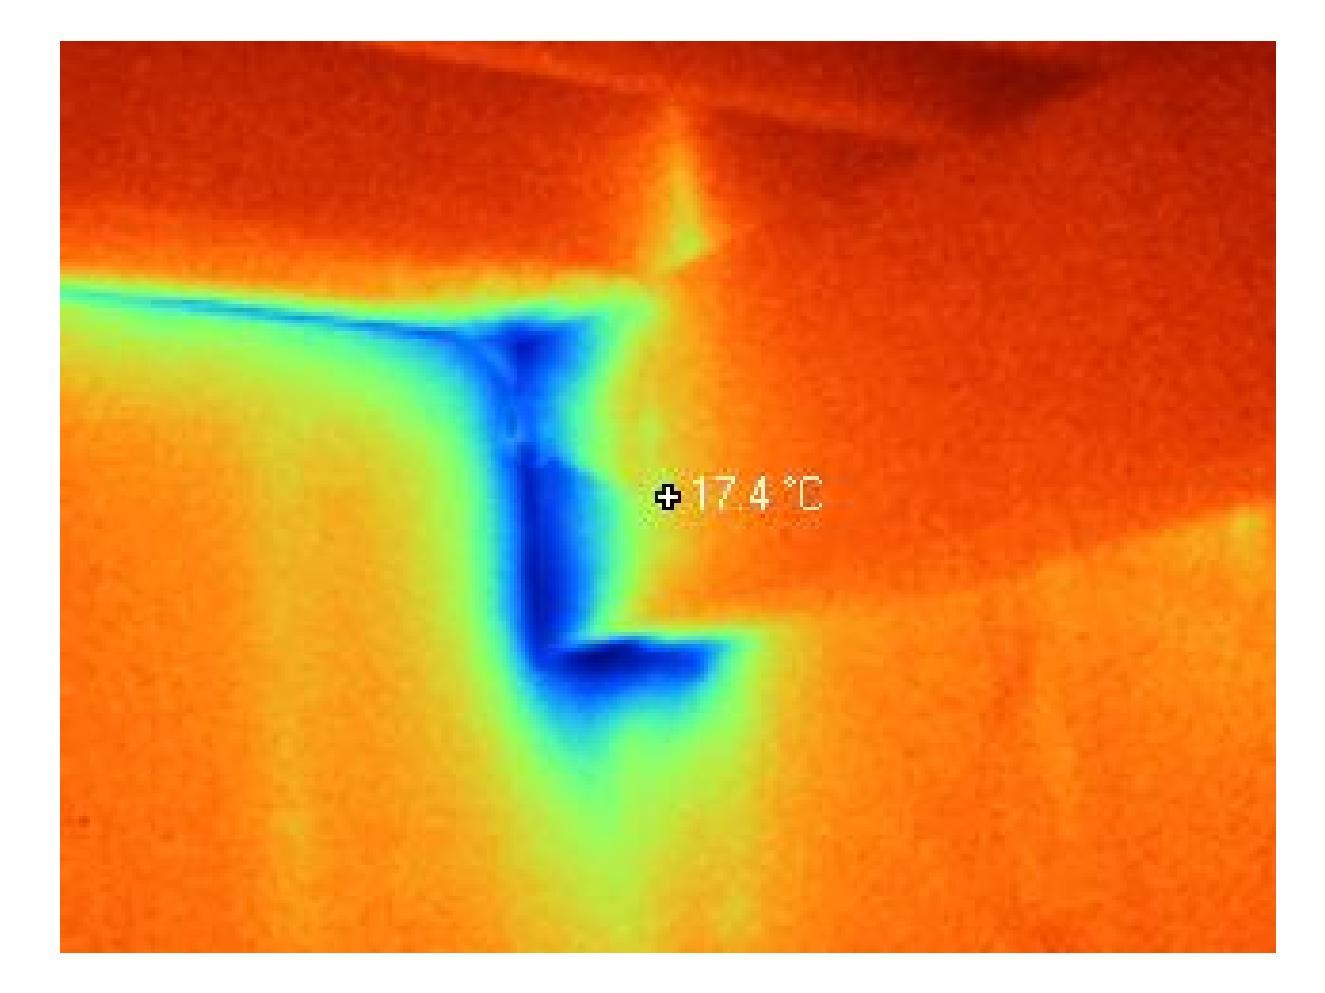
# Built up beam supporting main floor joists

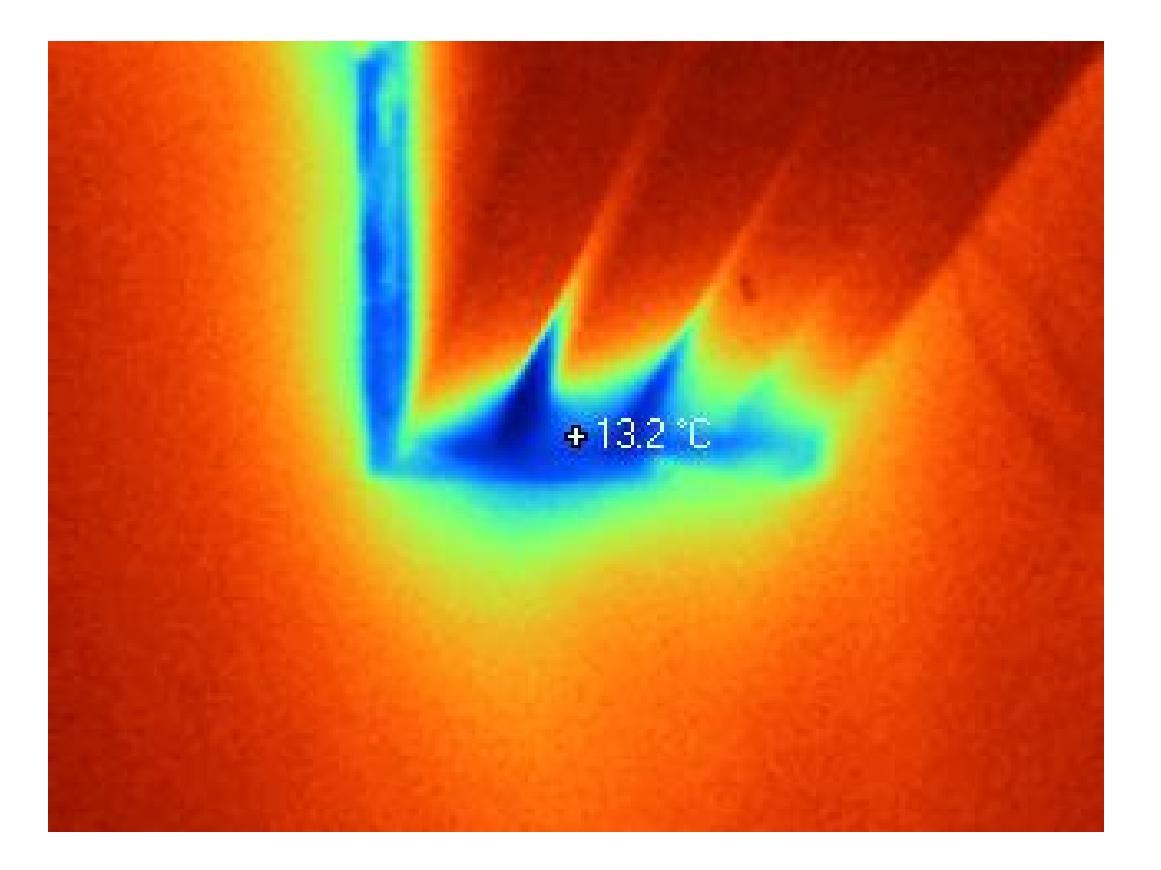
# Air leakage through spaces between built up 2 x 10 beam

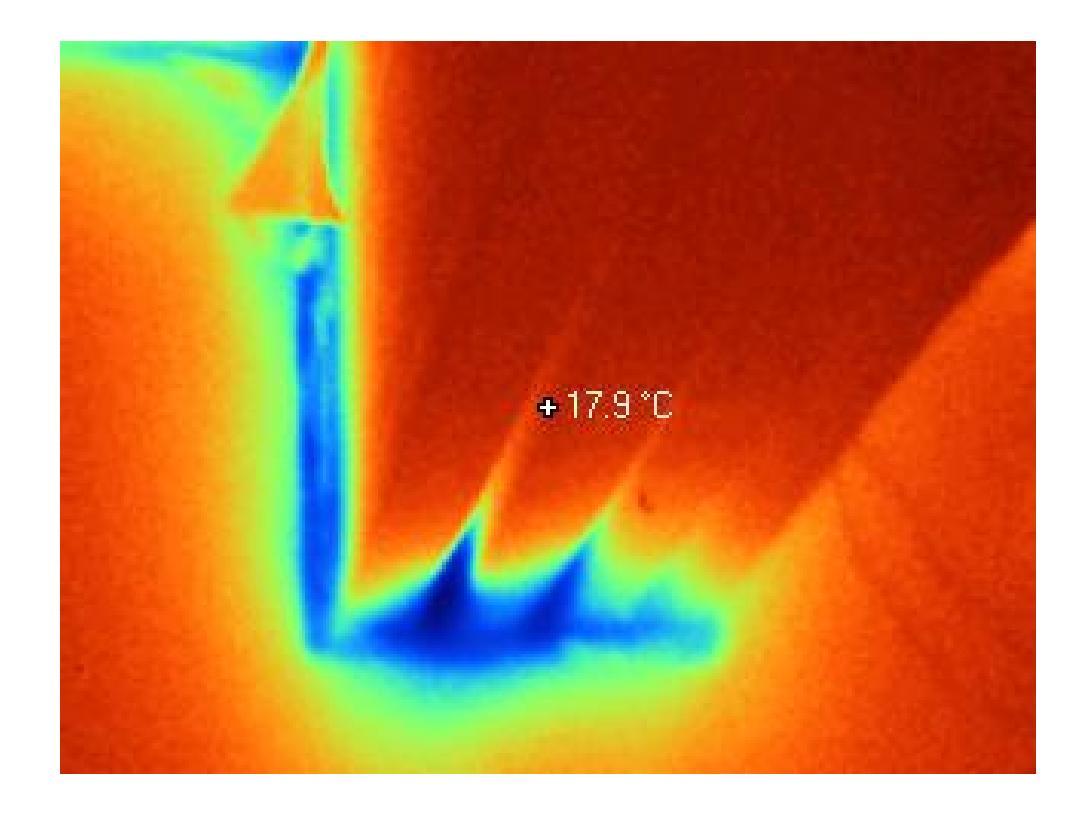
#### Surface Temperature Measurement on beam

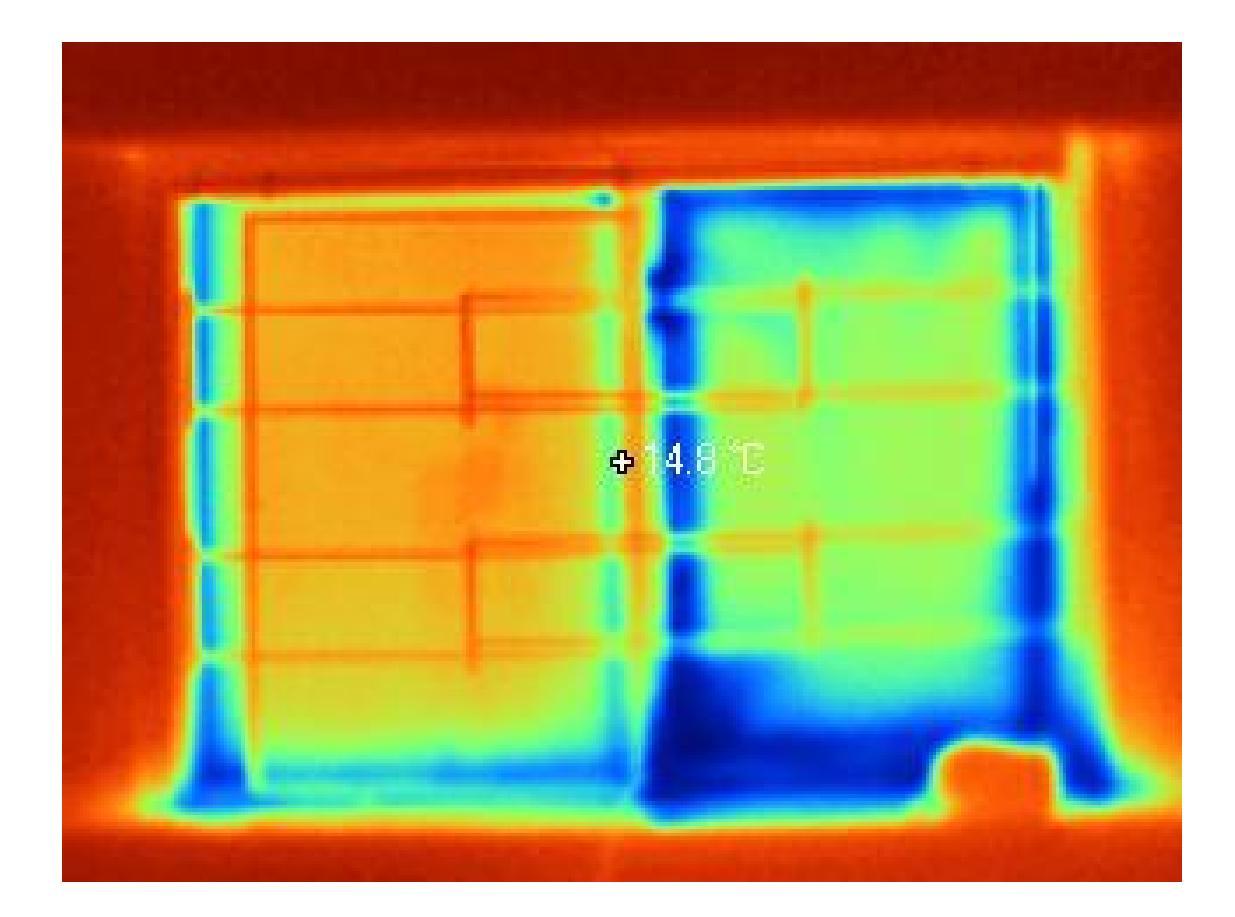
# Leaky Casement Window on Right (caused by poor closure of window)

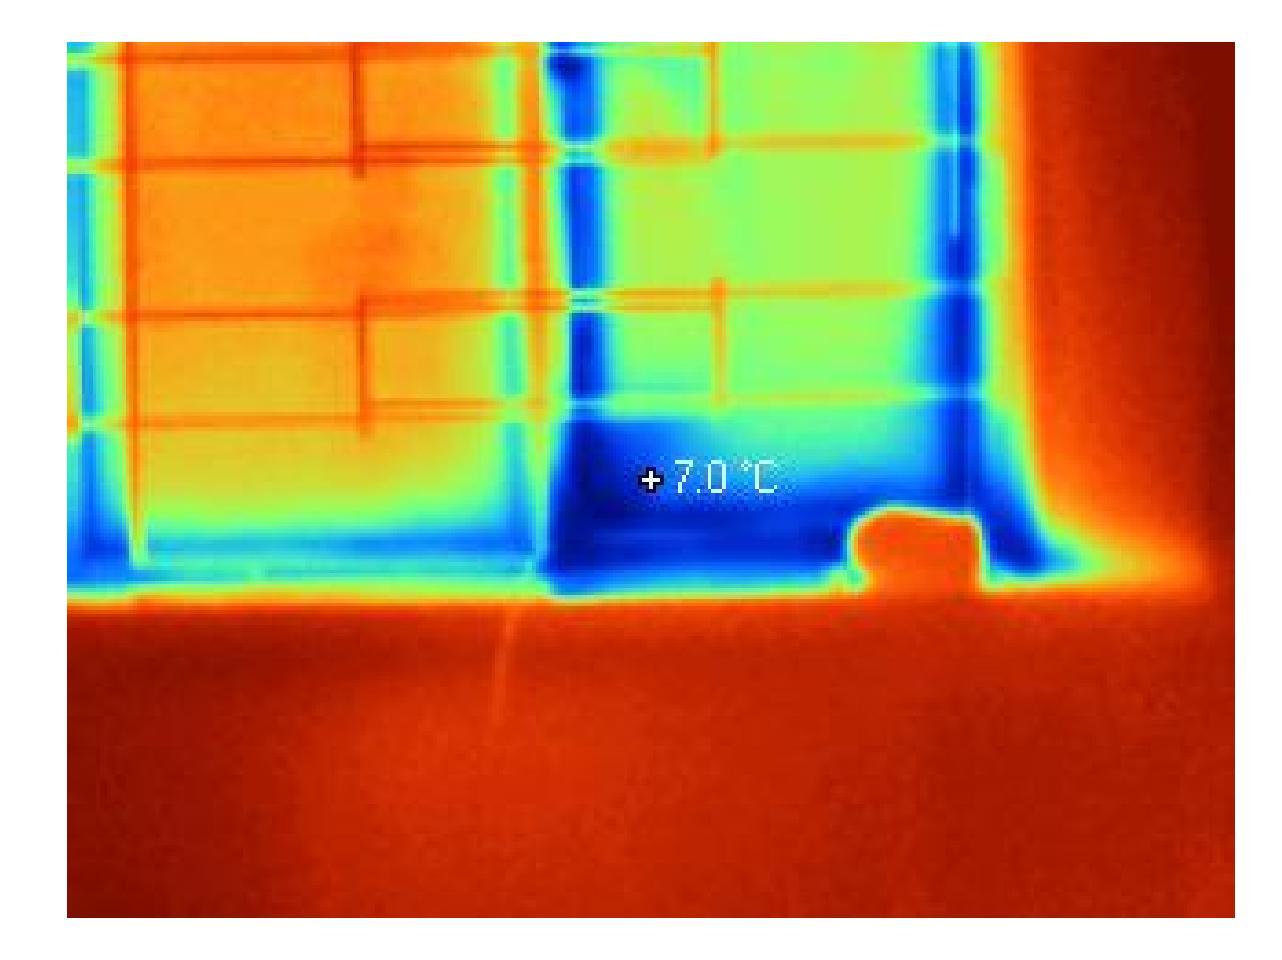
# Note cold temperature at base of window

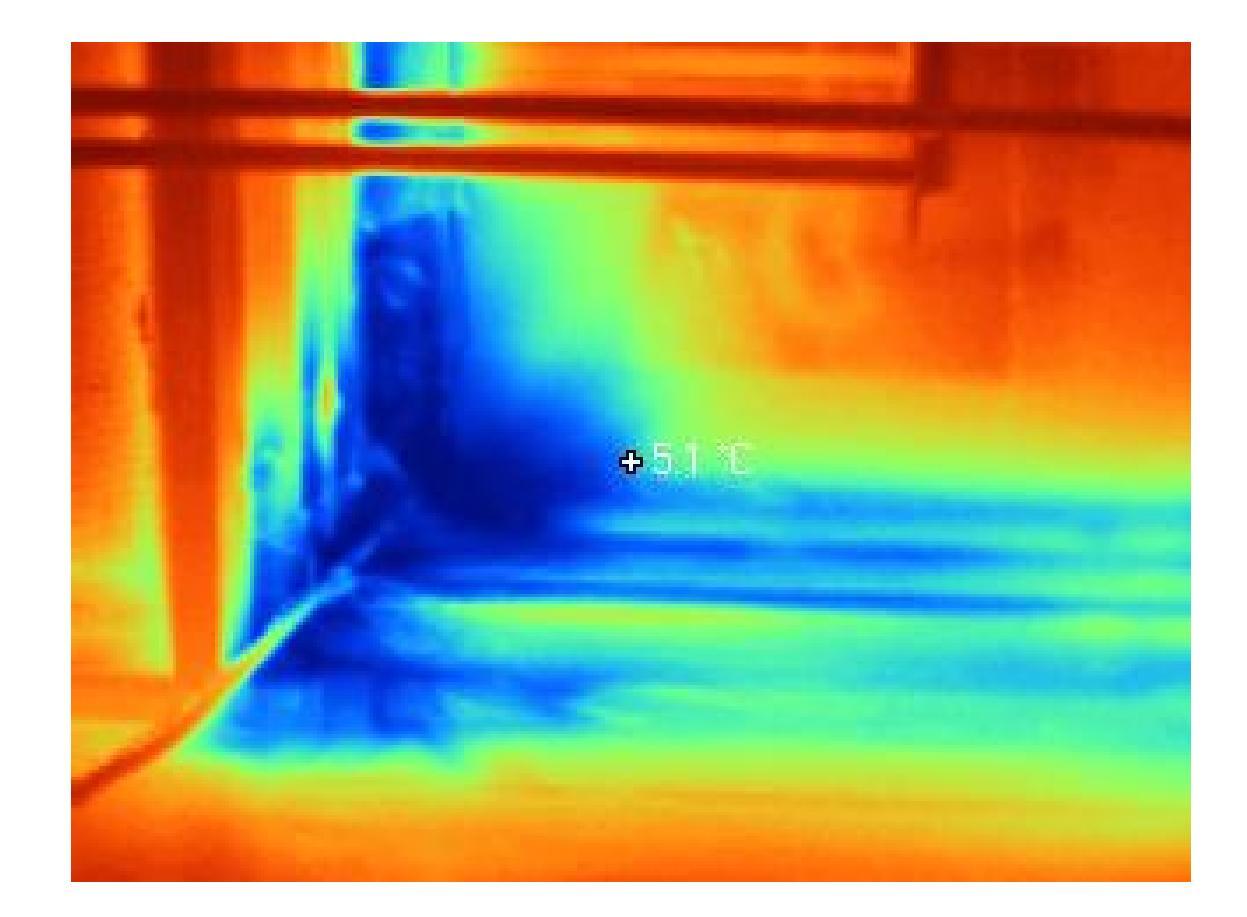
# Poorly closed window

Note window temperature.

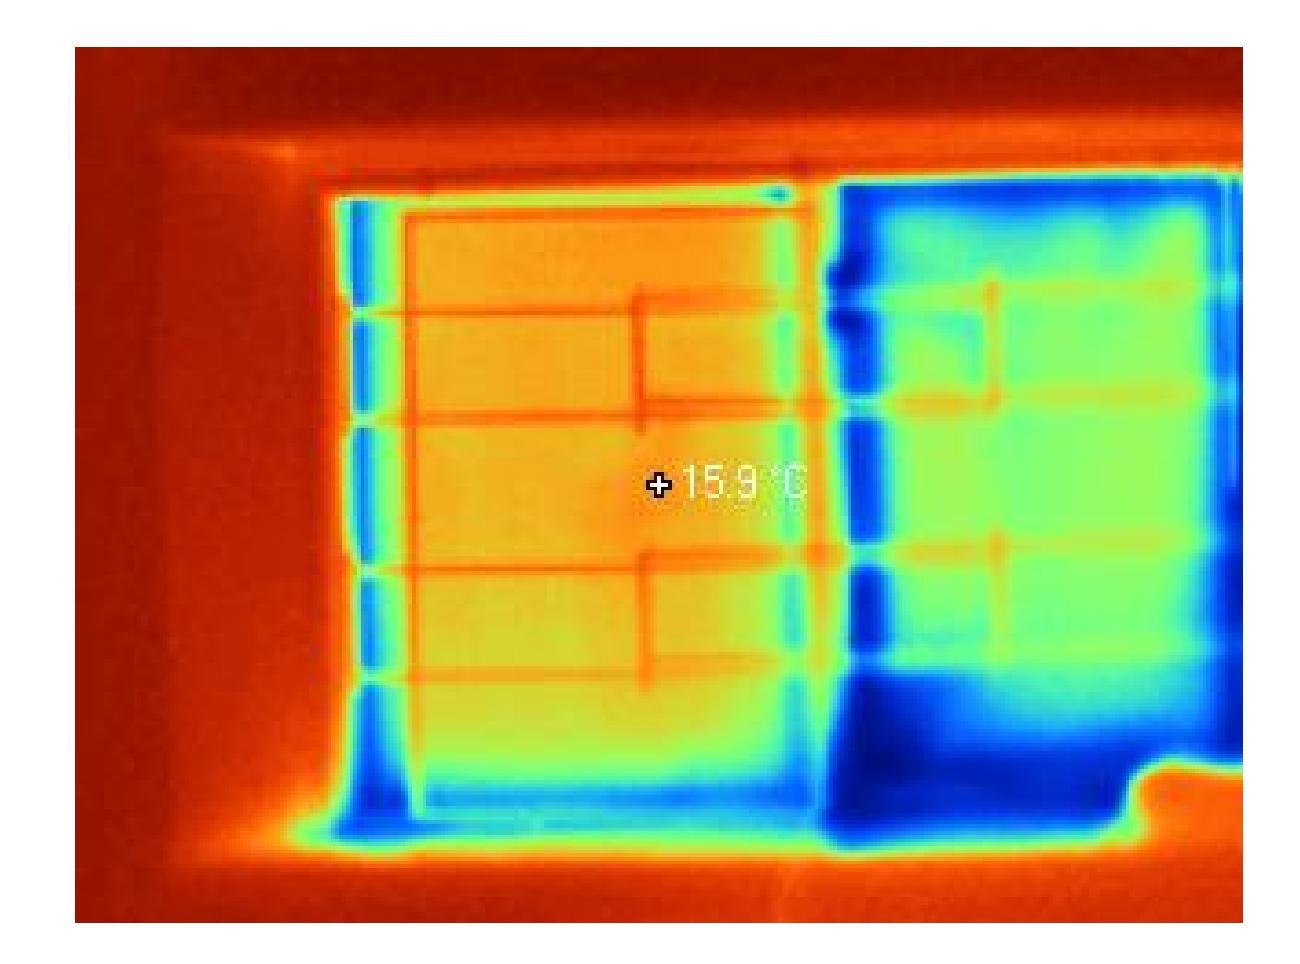
# Windows are triple glazed, low e argon filled units with non-metallic spacers

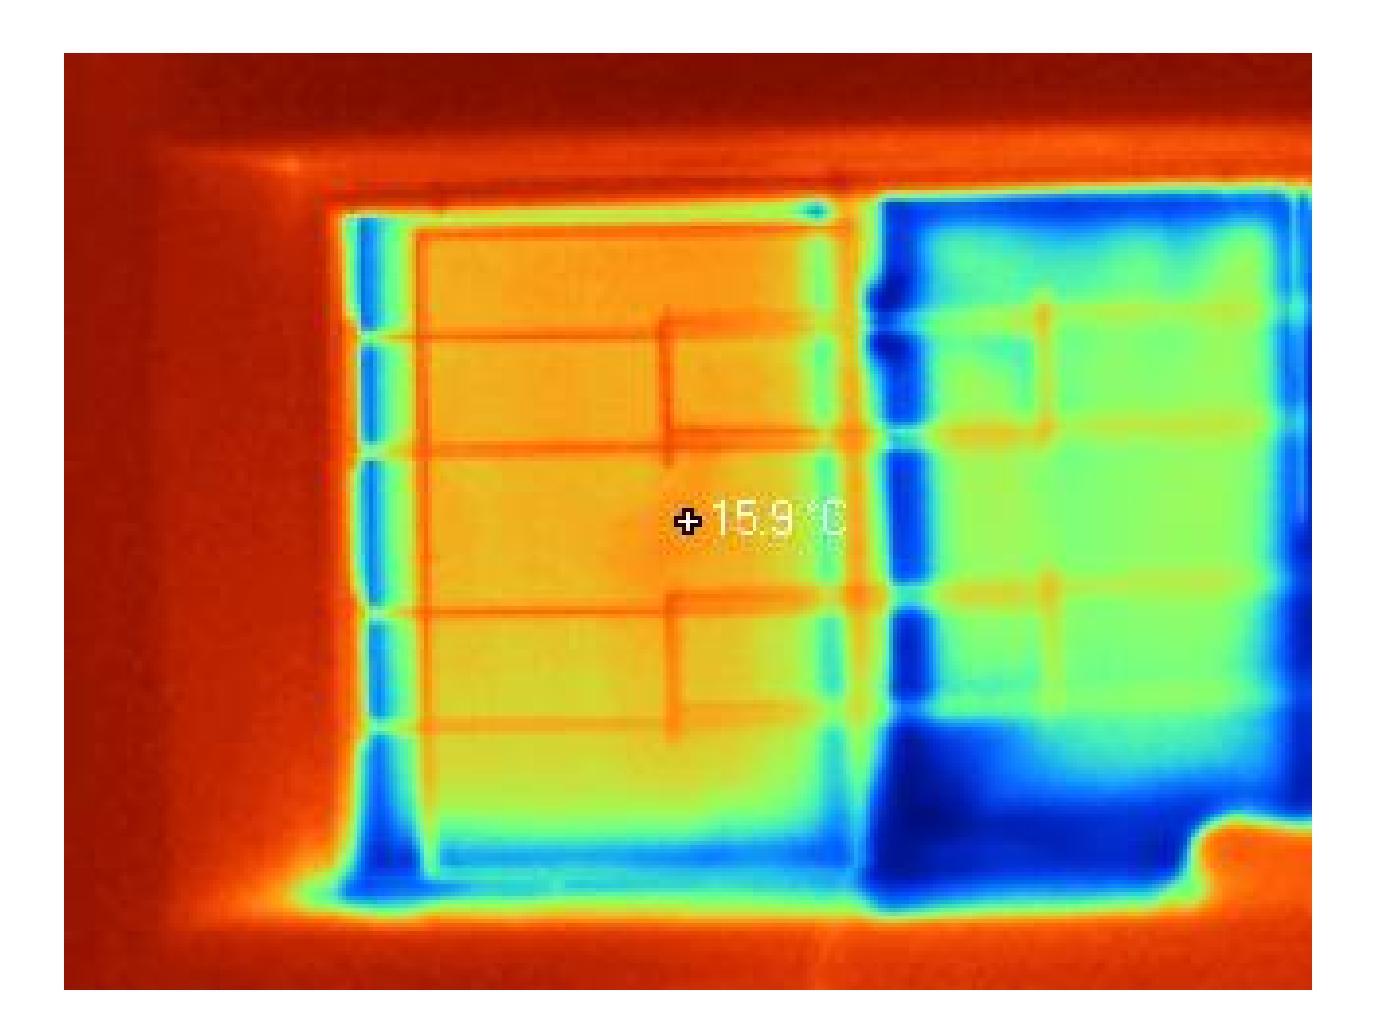
Note on the left window that the frame is cooler than the window glass. The frame has a poorer R value than the glass

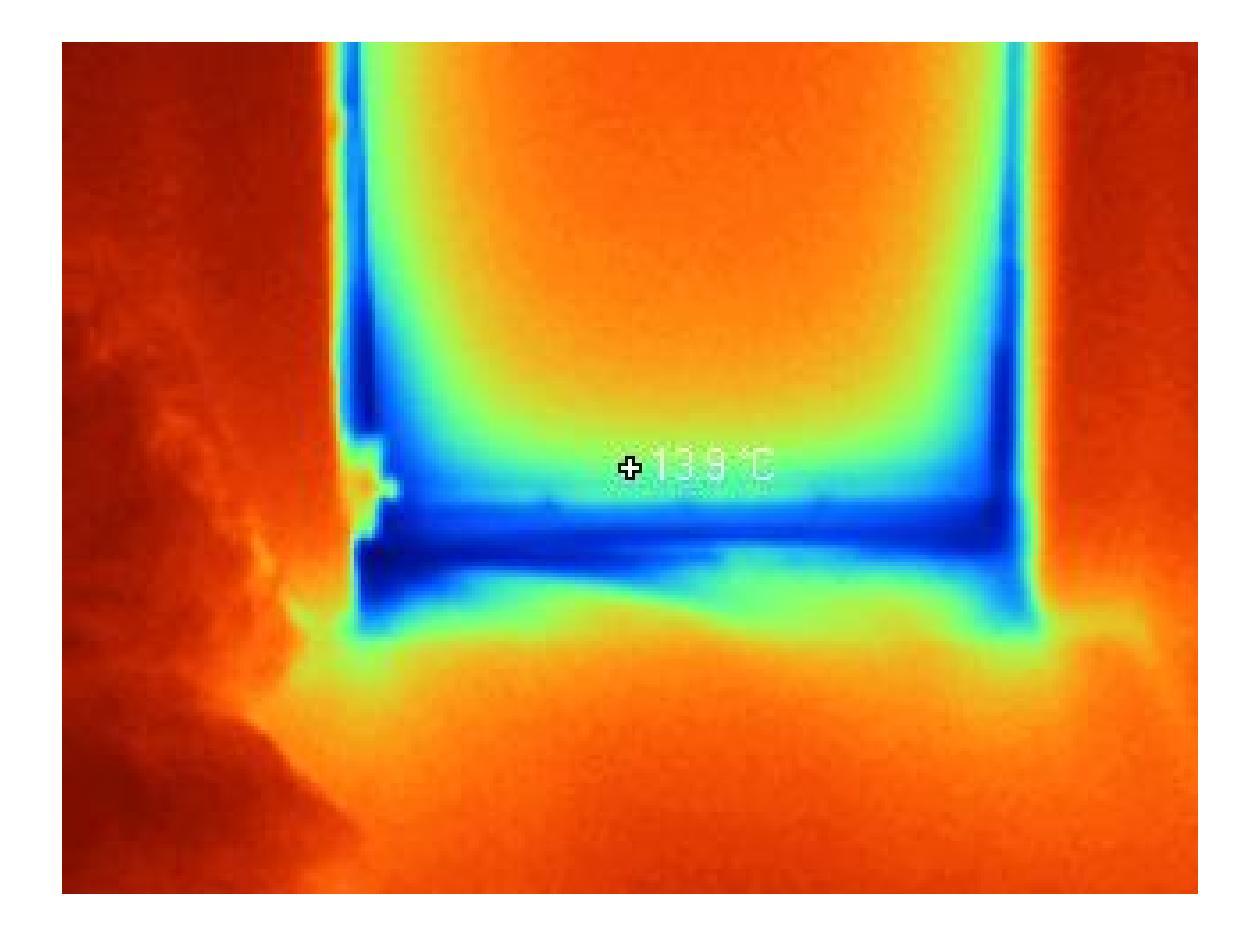
# More door problems with air leakage

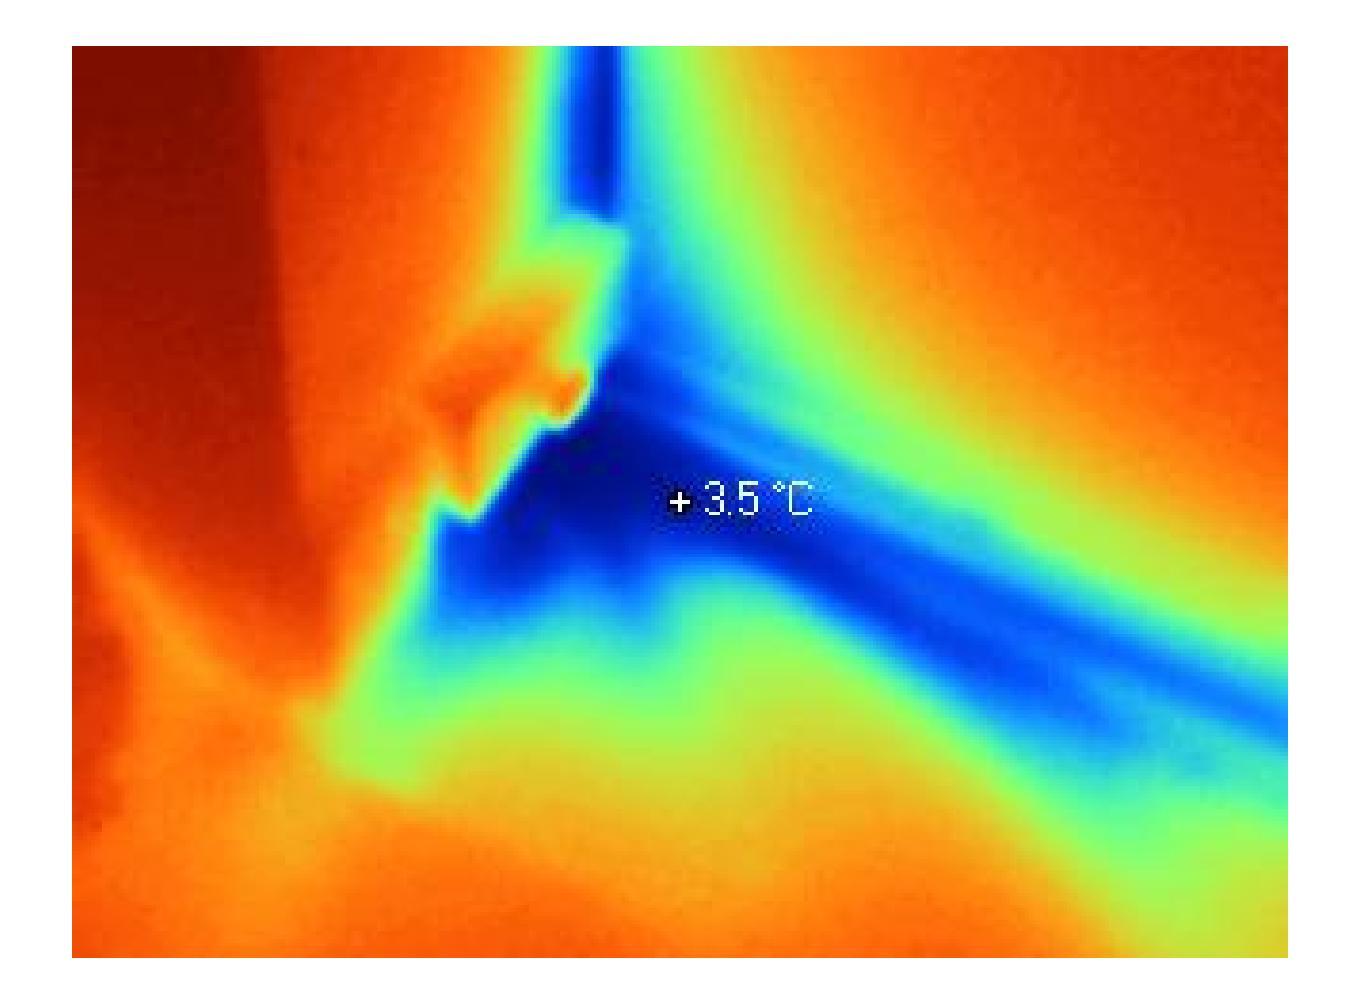
#### Temperature at bottom of the door

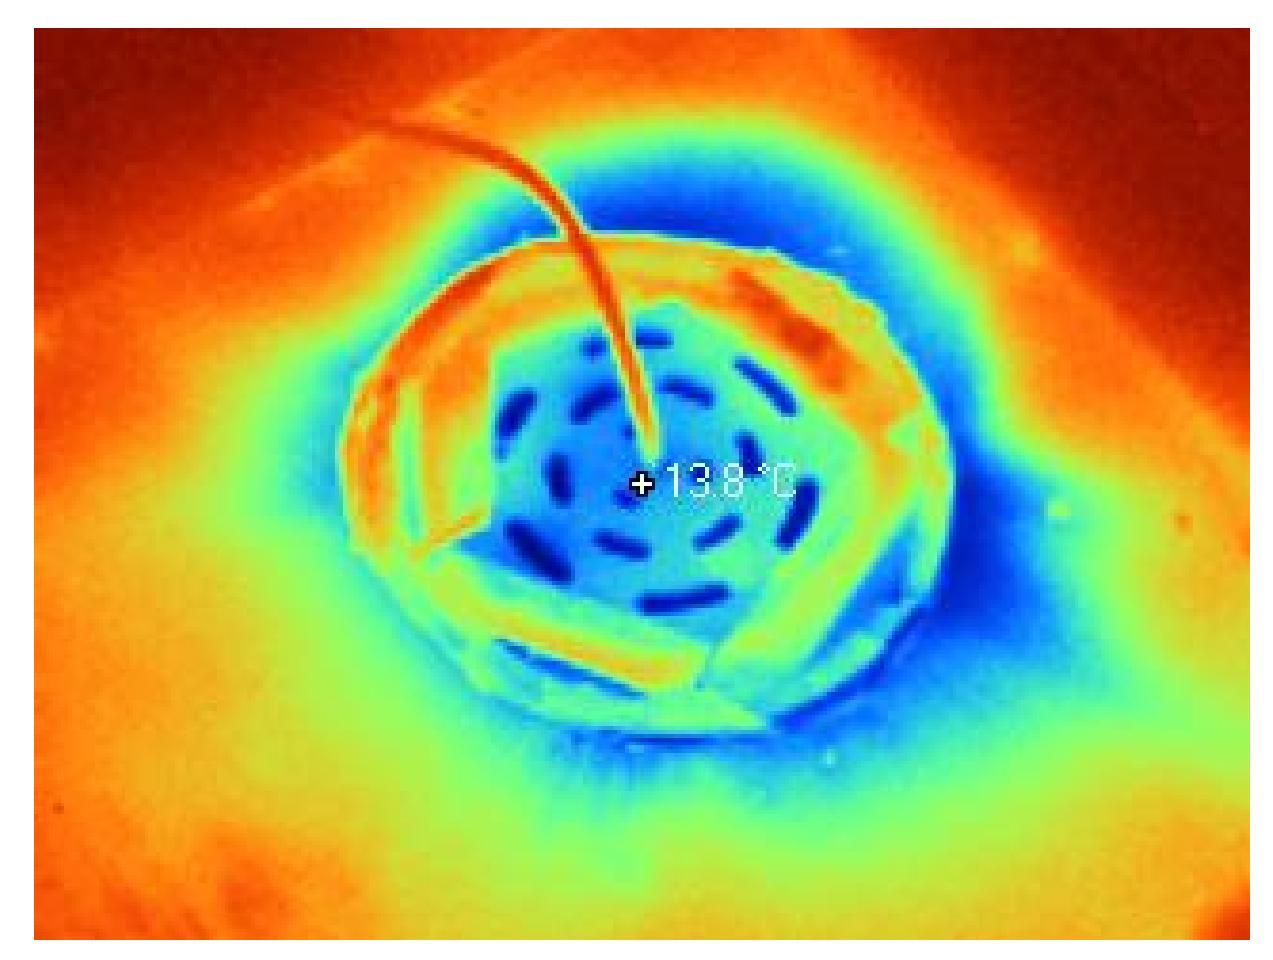
### Basement floor drain (unheated crawl space underneath)

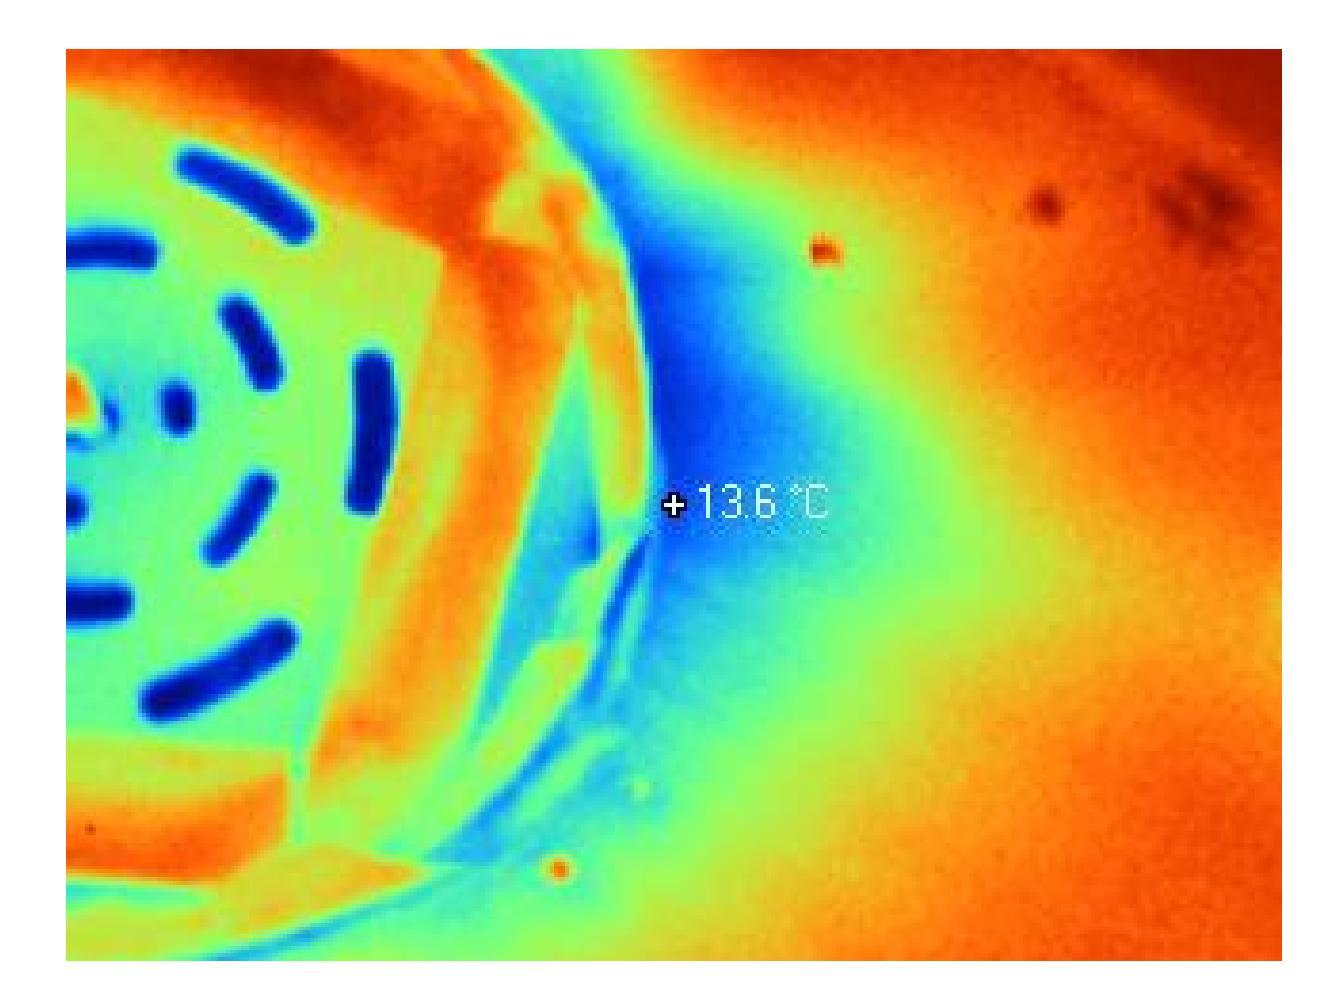
# Close-up of floor drain

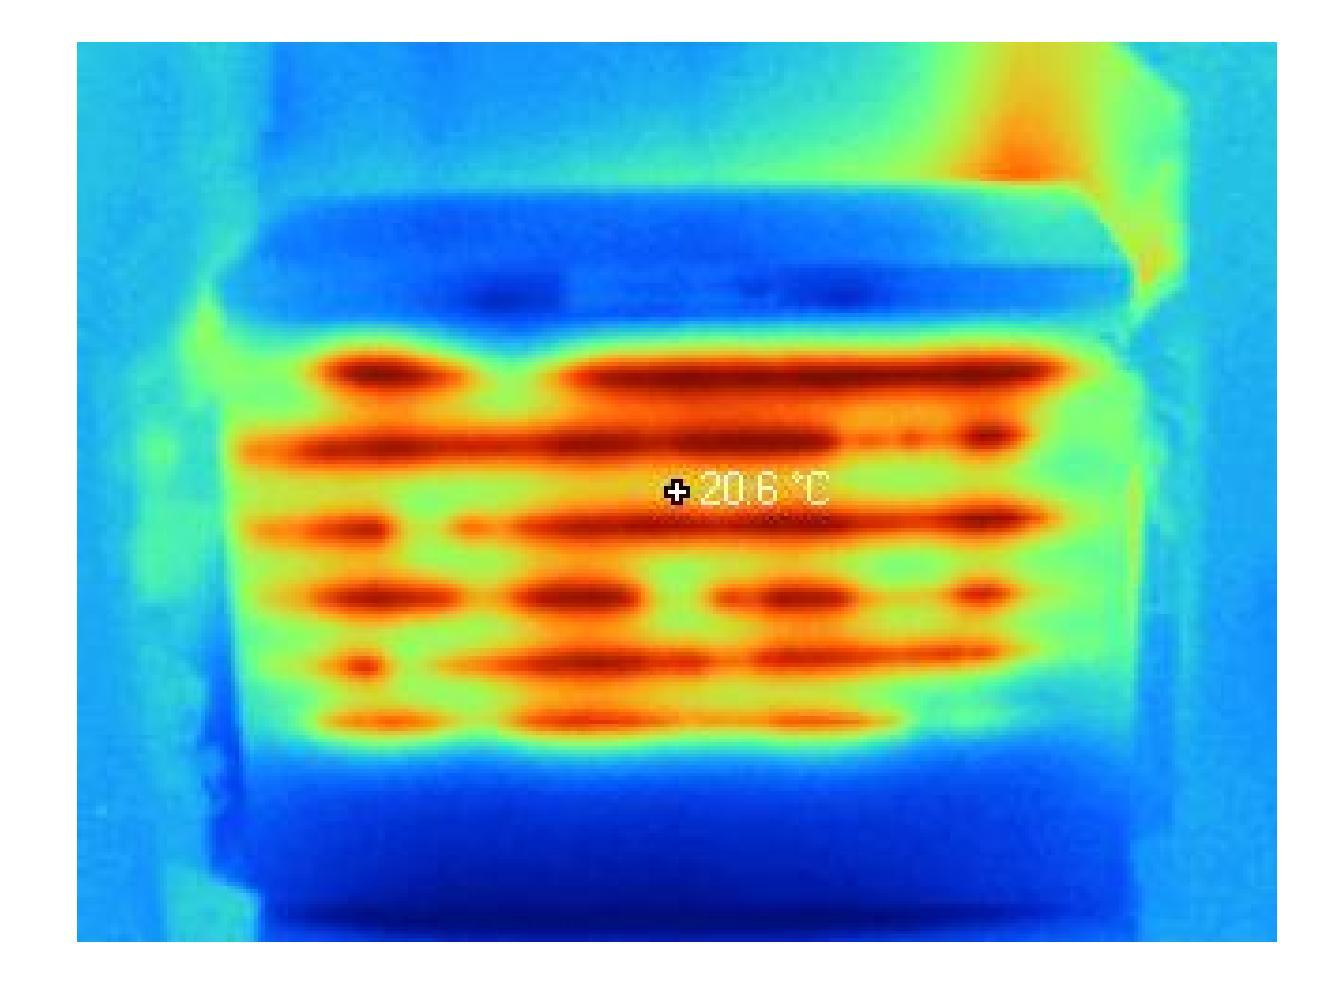
#### Chest Freezer in Operation (condenser buried in the metal skin causes the hot lines)

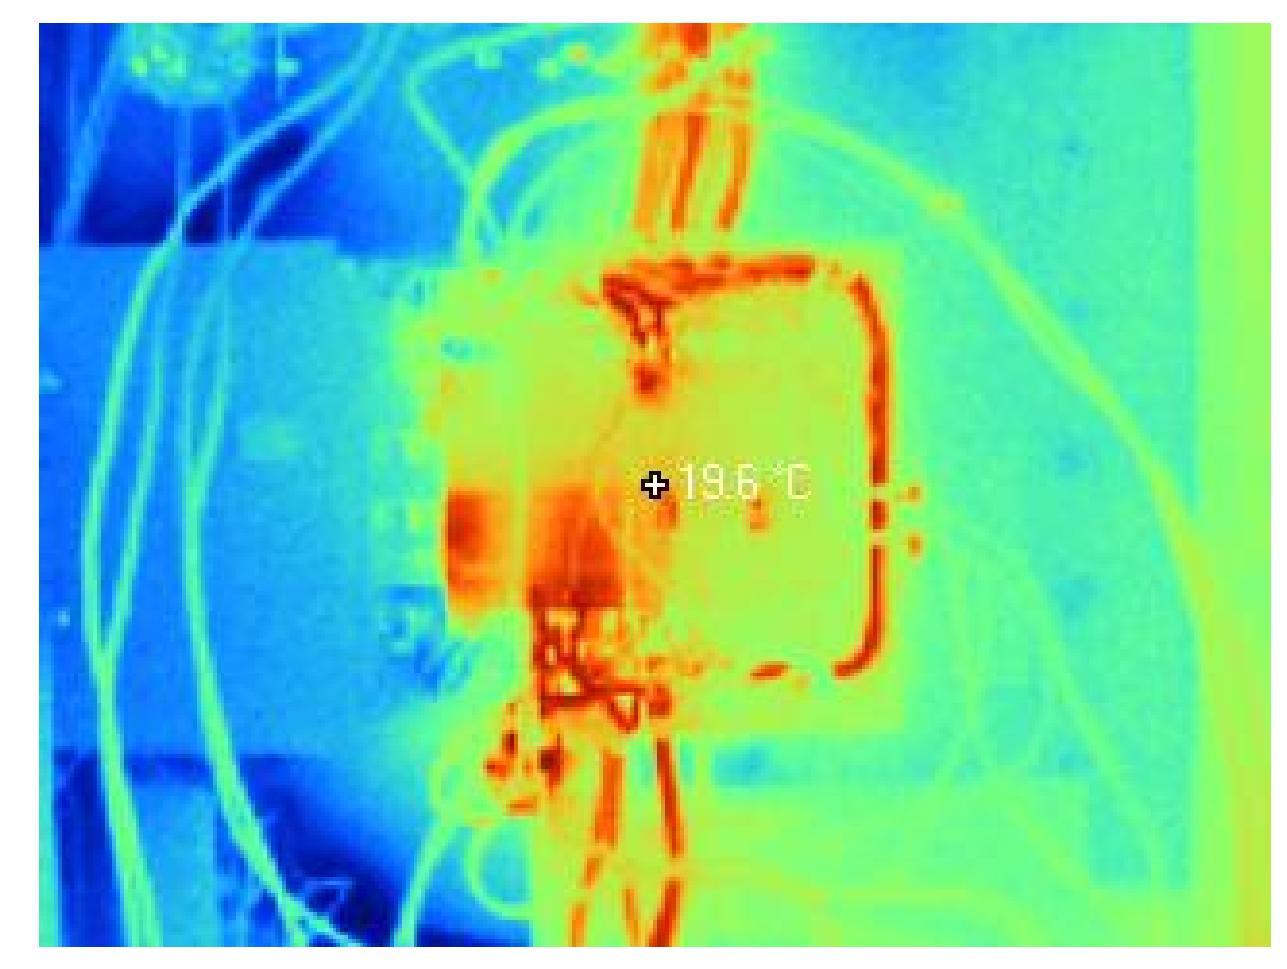
### Thermogram of the Main Electrical Panel for the house

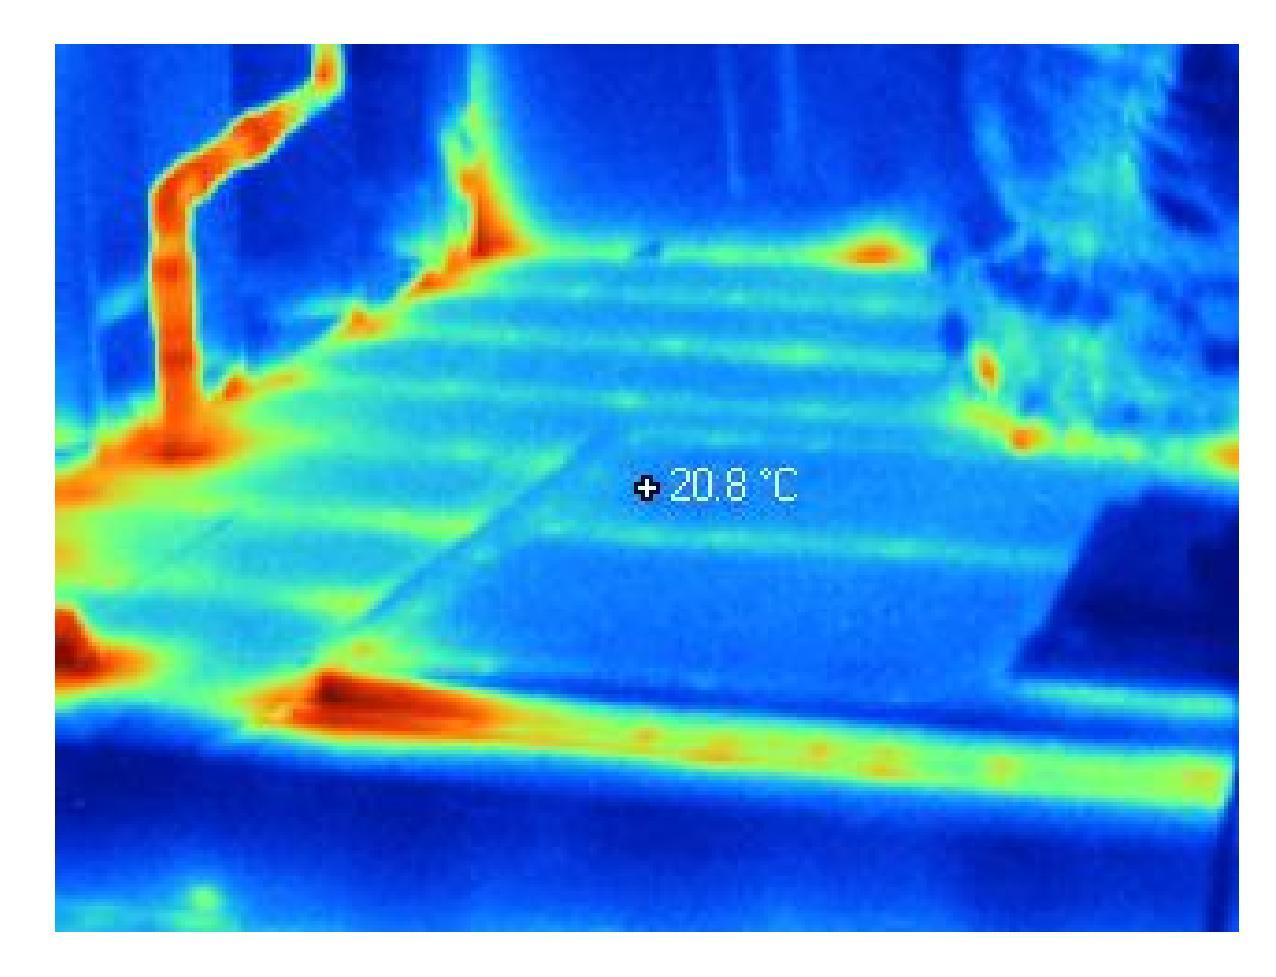
### Top of solar hot water storage tank (water in tank at 45 C)
