Infrared Thermography in the Dumont Residence March 2006

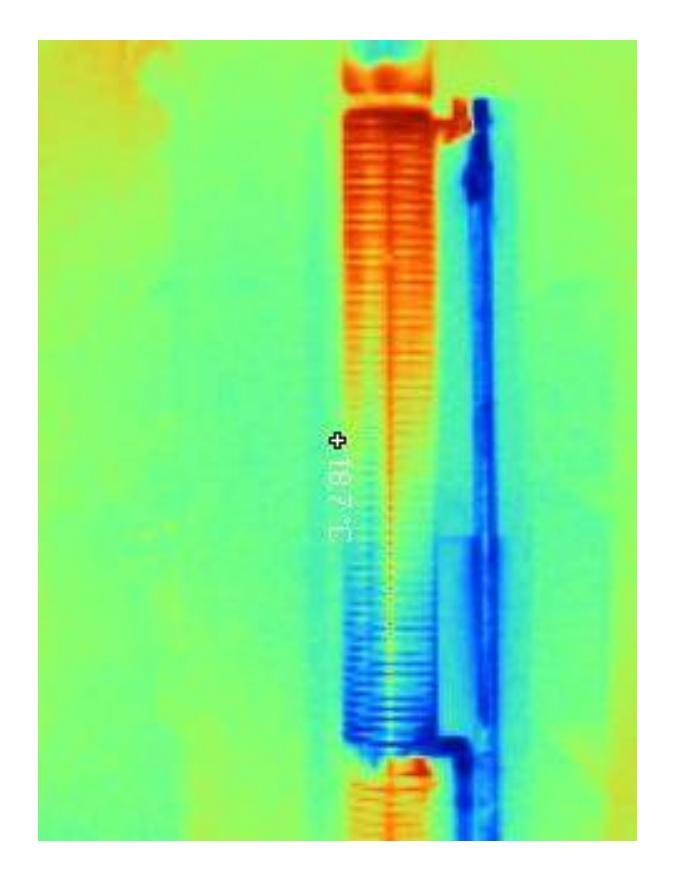
#### Top Half of GFX Unit

Hot Drain Water = 45 CCold Water In = 6 CCold Water Out = 25C
